**Building Number:** 34

**Original Name:** Supply/Shop  
Storage and Fire Station

**TABLE 1. • List Of Materials Testing Positive For Asbestos**  
Building 34, Truro Air Base, North Truro, Massachusetts

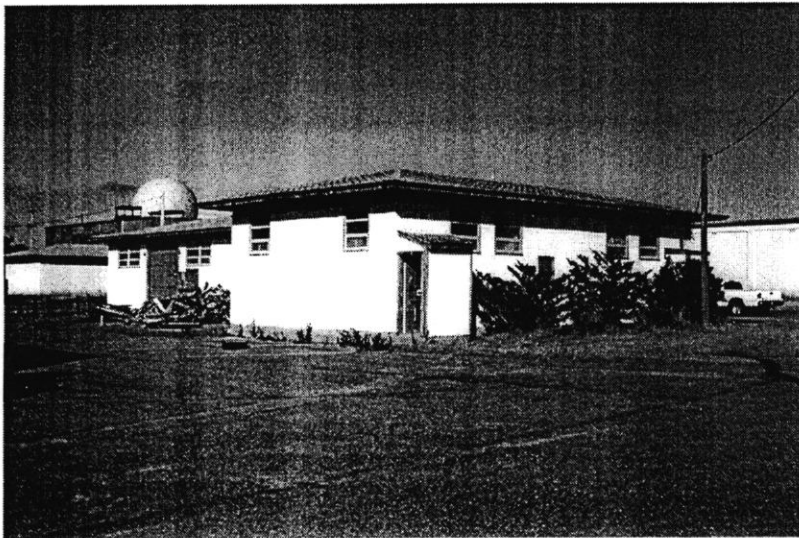
View from southwest.
